CASE STUDY – BONDPAK™

PROBLEM: Micro-channel Aluminum Coil Leaks

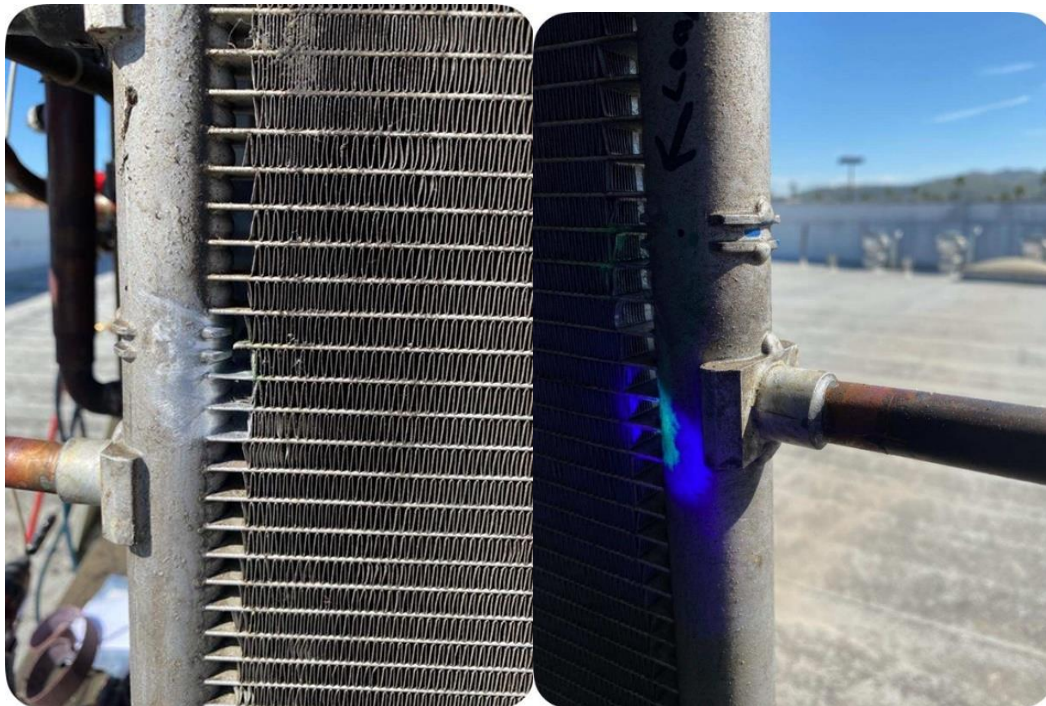
The A/C package unit shown here was built with an aluminum micro-channel condenser coil. Though only approximately 6 years of age, it had developed refrigerant leaks at four microchannel connections where they meet and attach to the vertical aluminum condenser manifold-header.

Aluminum brazing repair was not an option due to the delicate nature of the micro-channels and where they were connected to the manifold.

The technician decided to use BondPAK™ to make the repairs and avoid further damage to the coil.

Careful cleaning to remove oil residue and surface preparation with abrasion cloth and a file was done so that BondPAK™ could be used.

BondPAK™ was applied per instructions and at 1 hour was fully cured and ready for the system to be leak tested, evacuated, and charged.

After pressure testing and evacuation was complete, the unit was back on-line within 2 hours.
